**Attachment Q -  
Fredericksburg District  
Office Maintenance Yard**

**VDOT MS4 (General Permit No. VAR04)**  
**Fredericksburg District Office and Residency Complex**  
**VDOT District No. 6**

**Facility Name:** Fredericksburg District Office and Residency Complex

**Date of Visit:** October 23, 2012

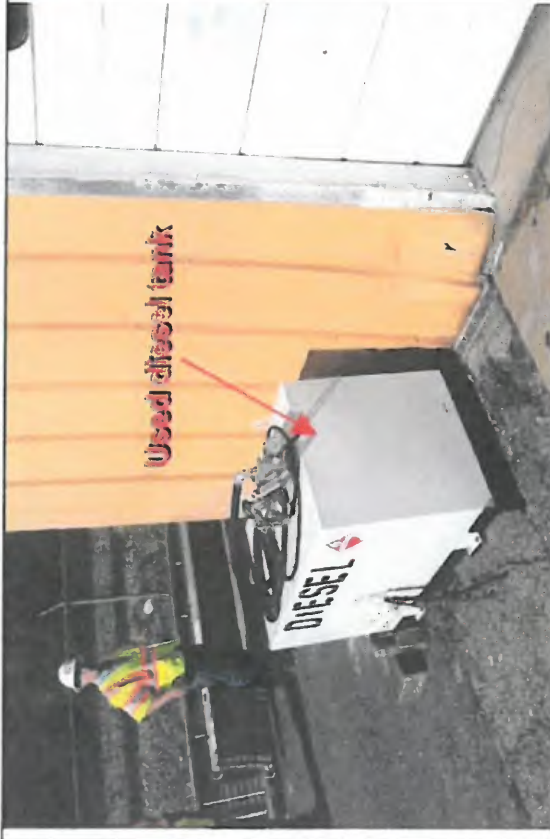
9. A portable diesel tank was observed stored outside on the south side of the construction office buildings in the southwest portion of the Facility, without containment or overhead coverage best management practices (BMPs) (see Photograph 13). It was unclear to the inspection team if the tank contained diesel product; however, fluid was present inside the diesel tank.

Photograph 13 – View facing northwest of a used diesel tank stored outside on the south side of the construction offices.

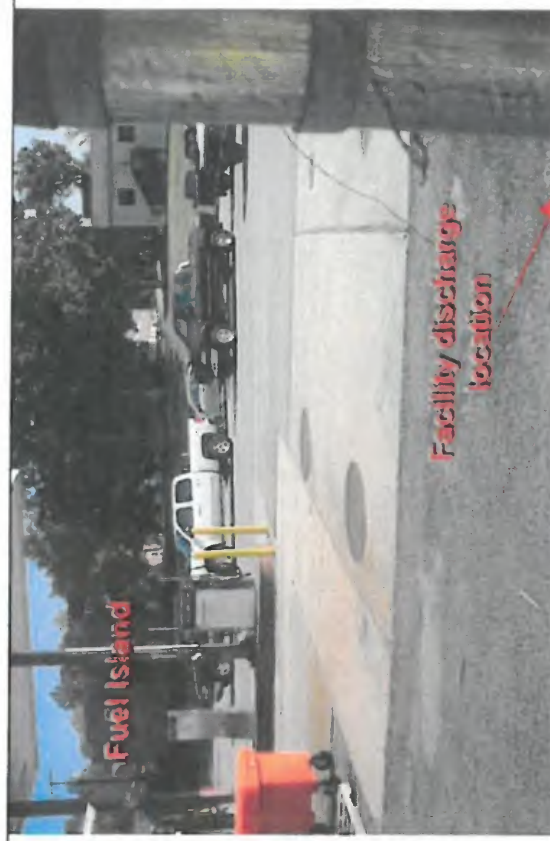
10. VDOT Facility staff did not have procedures for bulk fuel unloading, fuel vendors, or routine fueling of vehicles/equipment. The fuel island is located immediately upgradient of the western stormwater discharge location (see Photograph 14).

Photograph 14 – View facing east of the Facility fuel island located immediately upgradient of a Facility stormwater discharge location.

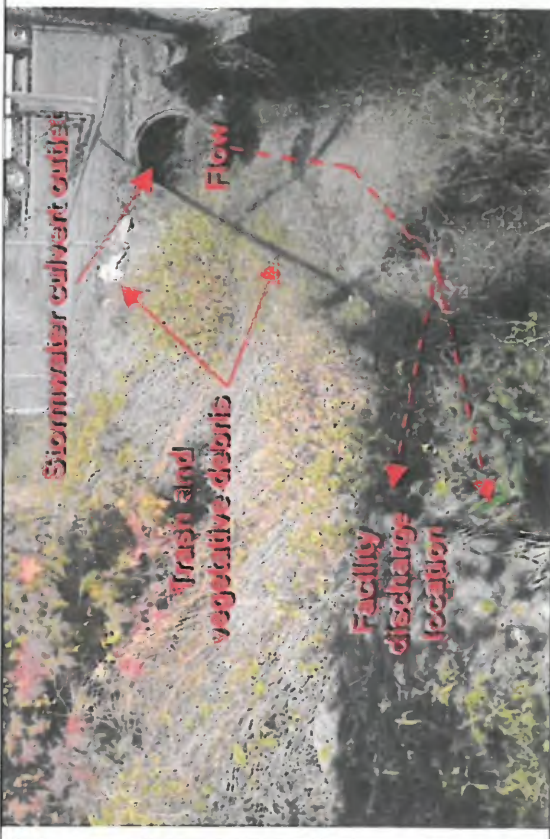
11. Trash and vegetative debris was observed at the Facility discharge location on the east side of the adjacent railroad tracks which run along the western perimeter of the Facility (see Photographs 15 and 16). The VDOT Facility District Maintenance Engineer stated that she had not observed cleaning operations at the Facility discharge location since her initial start date at the Facility (approximately 2 years).

Photograph 15 – View facing north of the Facility western stormwater discharge location.

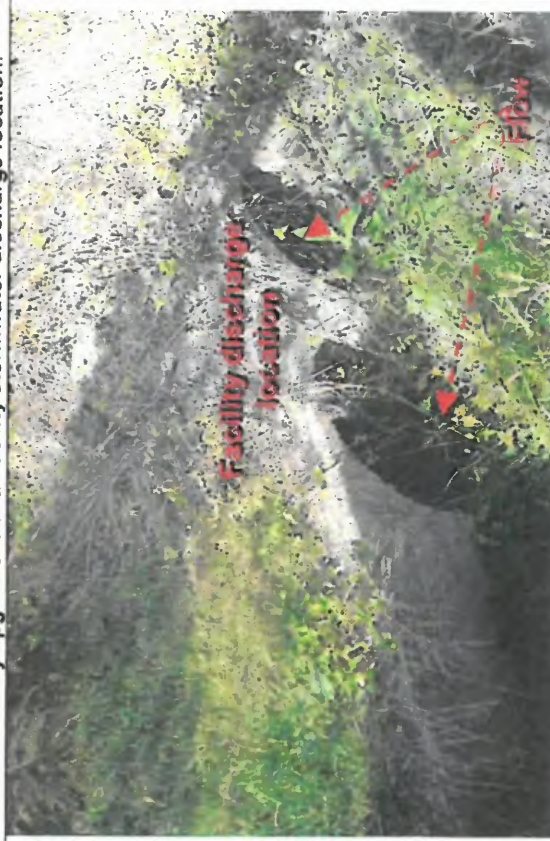
Photograph 16 – View facing northwest of the Facility western stormwater discharge location.

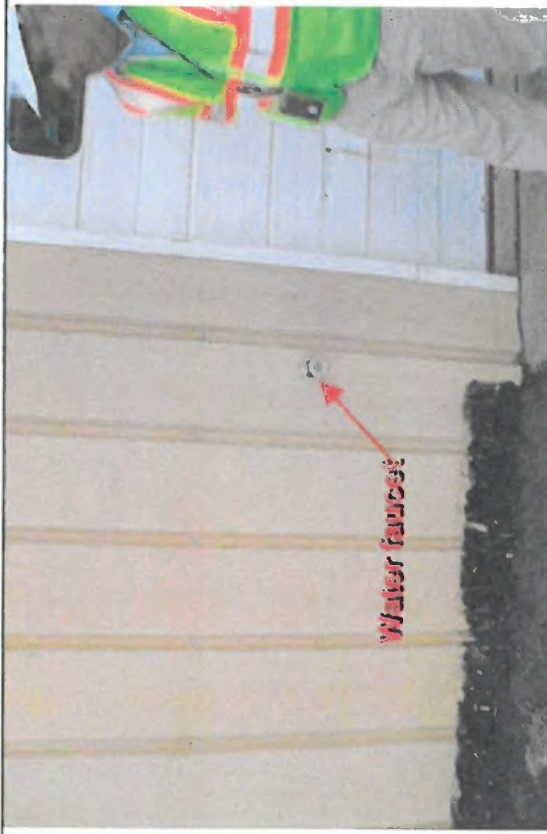
12. Numerous water spigots were located throughout the Facility. Specifically, a connected water faucet was observed on the north side of the construction office building (see Photograph 17), a connected hose bib was observed on the north side of the fueling island shack (see Photograph 18), and a connected water faucet was observed at the facilities building north of the vehicle repair storage area on the northern side of the Facility. No BMPs had been implemented to prevent washing activities from resulting in an illicit discharge.

Photograph 17 -- Close of view of a water faucet located on the north side of the construction office building. No signage was provided for the faucet.

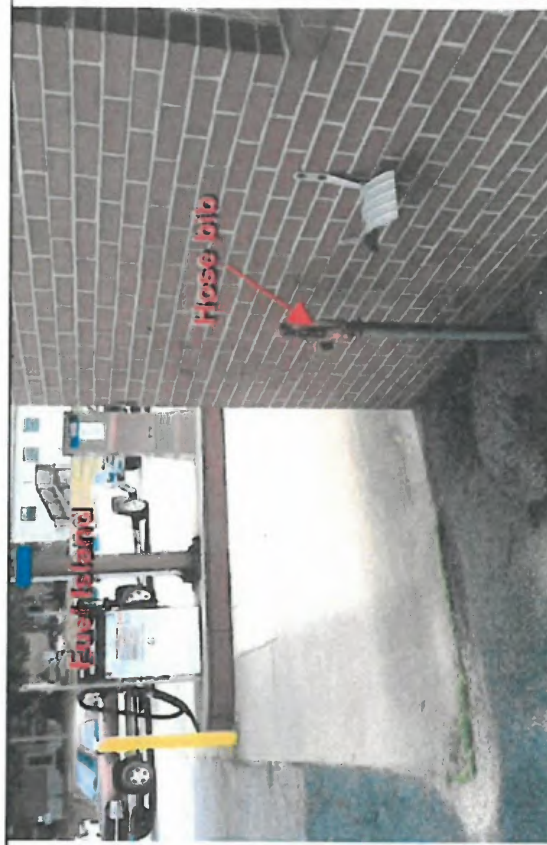
Photograph 18 -- View facing east of a hose bib located on the north side of the fuel island shack. No signage was provided for the hose bib.

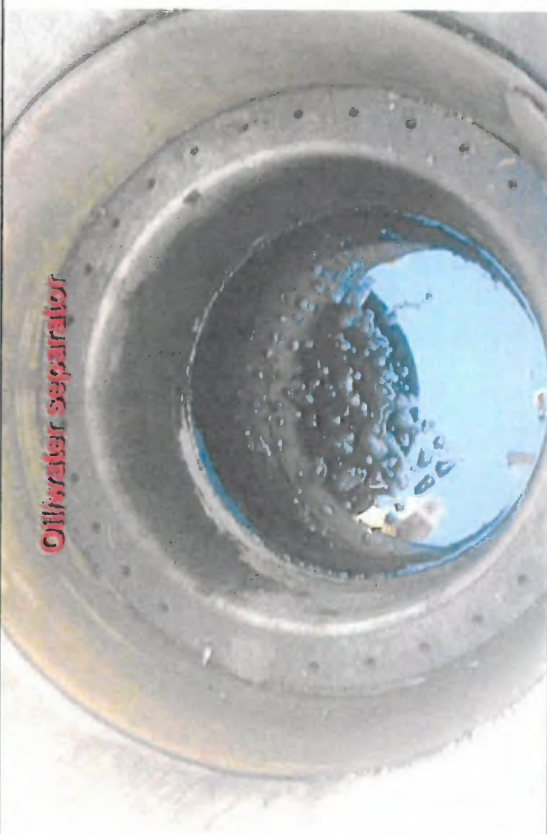
13. The oil-water separator located on the west side of the Facility and north of the fuel island was nearing capacity (see Photograph 19). The EPA Inspection Team confirmed that the oil-water separator was connected to the sanitary sewer system. Facility staff stated that there was no regular maintenance on the OWS; however, a maintenance program was being set up.

Photograph 19 -- Close-up view of the inside of the Facility oil/water separator. Note the separator appeared to be nearing capacity.
